# NATIONAL TRANSPORTATION SAFETY BOARD

## AIRCRAFT ACCIDENT REPORT

RYAN AIR SERVICE, INC.,  
FLIGHT 103, BEECH AIRCRAFT CORPORATION  
1900C, N401RA,  
HOMER, ALASKA,  
NOVEMBER 23, 1987

NTSB/AAR-88/11

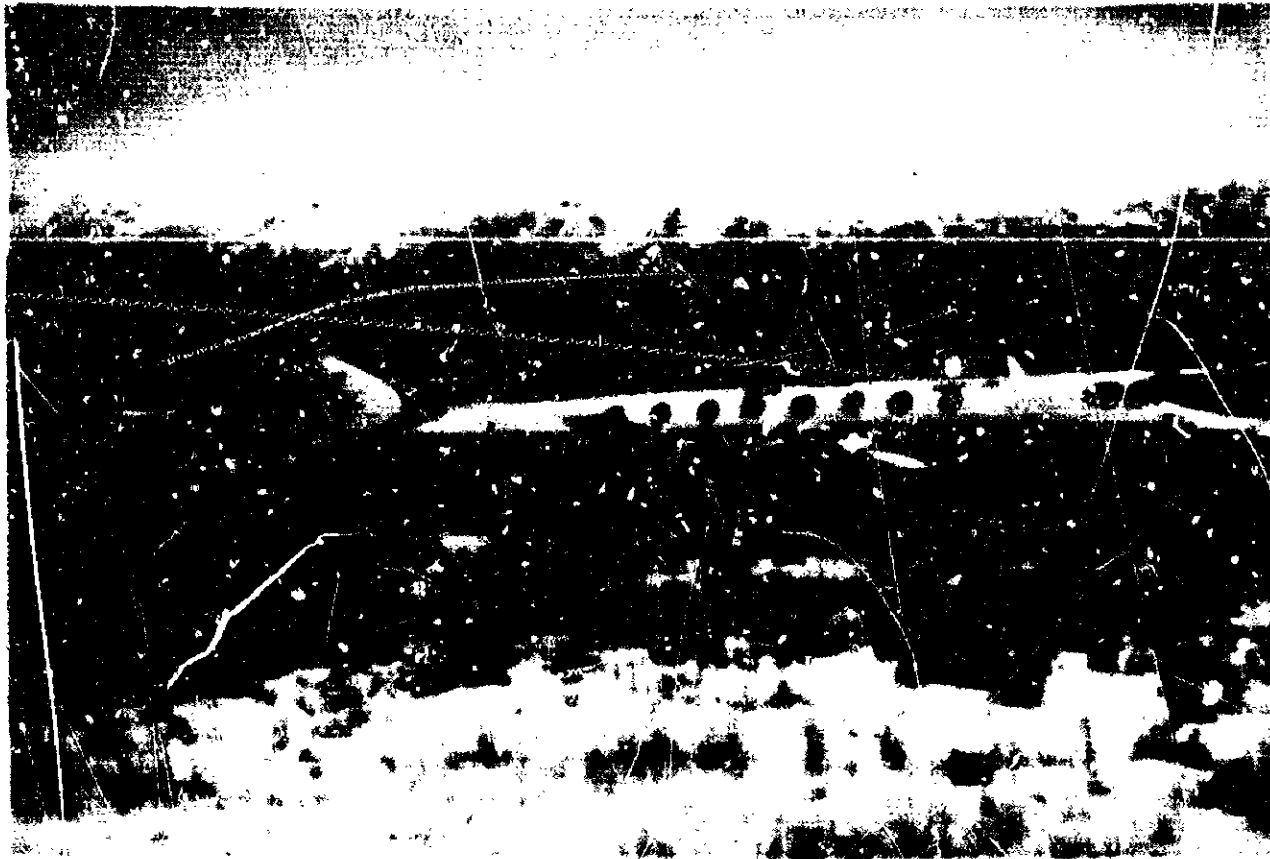
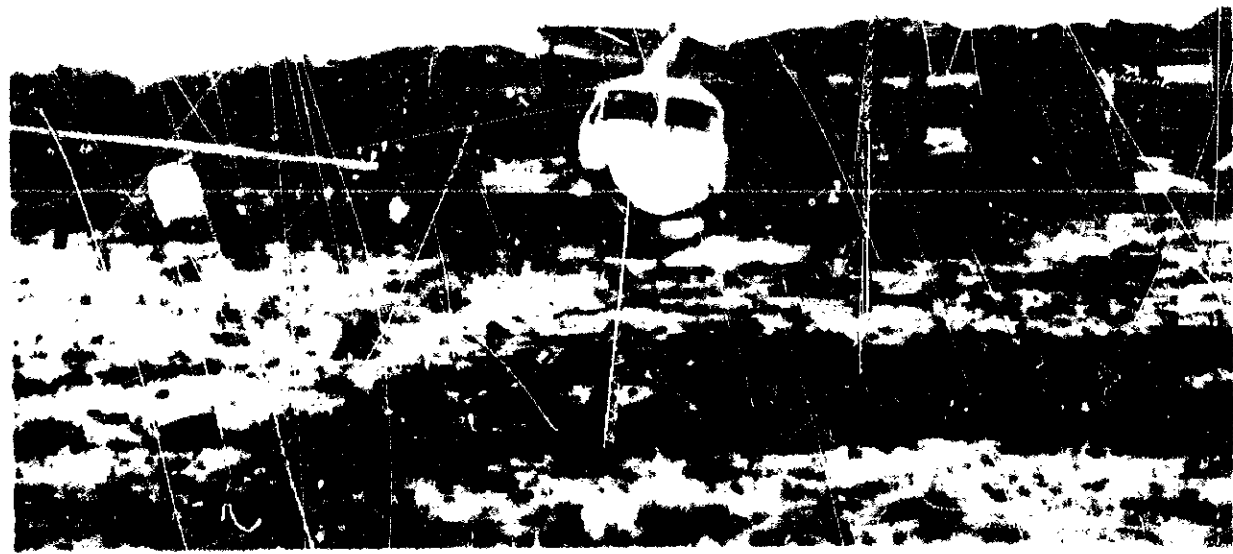
Figure 2.--Wreckage of RYA 103.

The airplane wreckage, located west of runway 3, was distributed along a distance of 159 feet, on a heading of approximately 355°. A video tape taken 4 hours after the accident revealed a thin ice accumulation up to 3/8 inch on the leading edges of the wings, horizontal stabilizers, stabilons, tailsets, vertical stabilizer, and nose cone. No other ice accumulation was observed on the airplane. The gear actuators indicated that the gear was down and locked at impact. (See figure 2.) The propeller blades of both engines, which were composed of composite material, were broken away at their hubs and were scattered along the wreckage path.

The lower wing surfaces were heavily damaged from their root end to outboard of the landing gear well. Numerous ribs were broken and/or crushed. The flap handle was in the up position. The left flap actuator attachment brackets were broken. The right flap actuator was found in an intermediate position, between 7° and 12°. Company procedure was to select full (35°) flaps when landing was assured.

The airplane's flight control system, including its cables, were found intact and functioning within acceptable parameters. The cockpit stabilizer manual trim wheel and the associated trim cables were found in the full nose-down position and against the full nose-down stops, respectively.
