Air Accident Investigation Sector

- Investigation Summary Report -

AAIS Case N° AIFN/0001/2015

Ground Equipment Collision with Aircraft

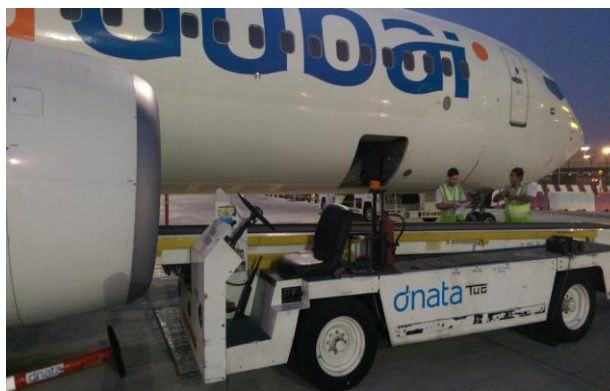
The operator realised that he now had to drive the MCB towards the vacant forward cargo door. The operator stopped the MCB and removed his feet from the MCB brake pedal in order to turn left towards the forward cargo door. Suddenly, the MCB moved forward towards the Aircraft and collided with the right engine causing damage to the engine shroud, acoustic panel, and inlet cowl (figures 1 and 2).

Figure 1. The MCB in contact with the engine. The MCB was parallel to the Aircraft

The Investigation was unable to determine the reason for the collision between the MCB and the engine. Two likely scenarios were considered; the MCB driver was distracted and his attention was diverted from the task at hand resulting in a loss of situational awareness or, instead of depressing the brake pedal he mistakenly depressed the accelerator pedal causing the MCB to impact the engine (figure 1).

- Marshalling for all equipment positioning to an aircraft
- Marshalling training of all staff working within the Equipment Restraint Area (ERA)
- Revised work instruction showing correct approach of MCB or any GSE at the forward and aft hold of an aircraft.”

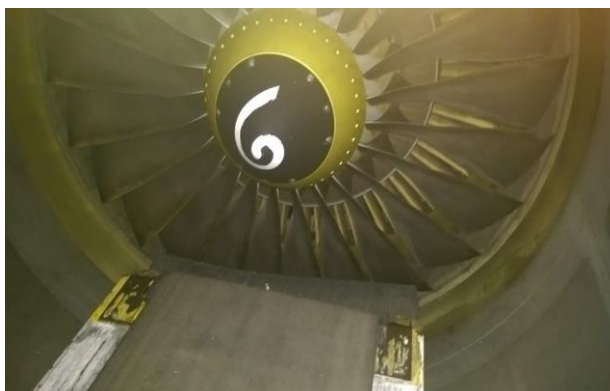
- The engine shroud sustained damage at the 6 o'clock position.
- Acoustic panel tear at the 8 o'clock position.
- One deep long scratch on the right engine inlet cowl at the 8 o'clock position (figure 2).

Figure 2. Final position of MCB inside engine inlet damage
