SERIOUS INCIDENT

Aircraft Type and Registration:	Boeing 777-200, AP-BGZ	
No & Type of Engines:	2 General Electric GE90-110B1 turbofan engines	
Year of Manufacture:	2006 (Serial no: 33782)	
Date & Time (UTC):	22 August 2019 at 1625 hrs	
Location:	Birmingham Airport	
Type of Flight:	Commercial Air Transport (Passenger)	
Persons on Board:	Crew - 11	Passengers - 209
Injuries:	Crew - None	Passengers - None
Nature of Damage:	None	
Commander's Licence:	Airline Transport Pilot's Licence	
Commander's Age:	61 years	
Commander's Flying Experience:	22,500 hours (of which 9,000 were on type) Last 90 days - 180 hours Last 28 days - 60 hours	
Information Source:	Aircraft Accident Report Form submitted by the pilot

Synopsis

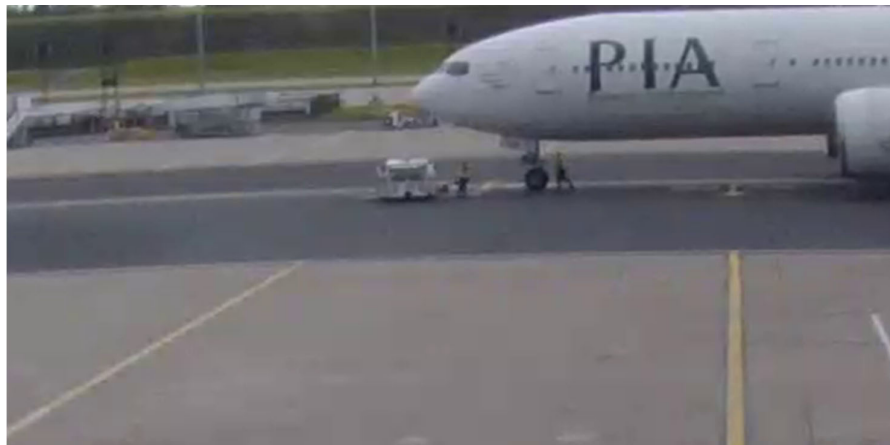
Figure 1
AP-BGZ begins to move

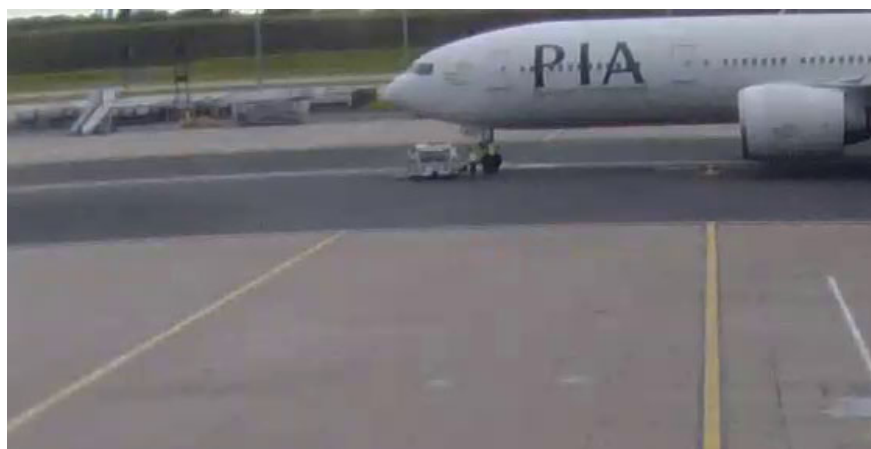
Figure 2
AP-BGZ approaches the towbar and tug
