Loading related event involving Airbus A320, VH-VQC

Gold Coast Airport, Queensland, 29 October 2016

ATSB Transport Safety Report
Aviation Occurrence Investigation
AO-2016-145
Final – 24 March 2017

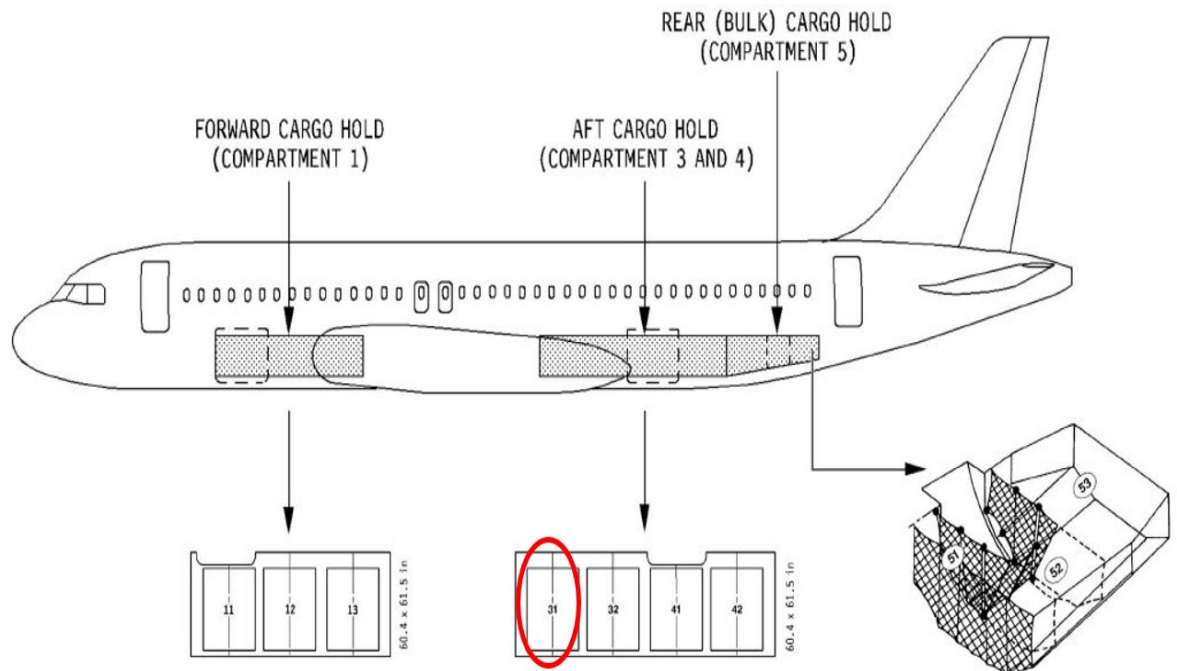
Figure 1: Aircraft hold positions (with position 31 highlighted)

Once the aircraft arrived, the leading hand estimated the unloading would require three dollies² and retrieved the dollies to unload the aircraft. Loader operator 1 unloaded containers from positions 41, 42, and 32 (Figure 1). Both loader operator 1 and the leading hand assumed only three containers needed to be unloaded.

After unloading, the loading procedures require a check of the aircraft hold to confirm if there are any containers remaining in the hold. The loader operator 1 reported checking the hold, however as they were walking towards the hold door, watching their footing, they did not detect a container in position 31. The leading hand witnessed loader operator 1 checking the aircraft hold and assumed all containers had been unloaded.

- Normally when they operate as loader operator, they have always fully loaded or fully unloaded the aircraft.
- During unloading, if you are standing at the controls of the loader you cannot see position 31, only part of 32, and positions 41, and 42. It is only when you walk into the compartment door, or stand on the very edge of the loader at the door are you able to see position 31.
- They were feeling fatigued on the day due to a lack of, and poor quality sleep the previous night. They were also feeling a little dehydrated at the time.

After unloading, all compartments are to be checked and confirmed as empty. Loader operator 1 did check the hold, but did not see the container in position 31. The leading hand witnessed loader operator 1 checking the hold, but did not check the hold themselves.

- The lack of loading documentation received at the Gold Coast resulted in the ground crew not knowing the number of containers to be off-loaded from the aircraft. Loader operator 1 did not detect the container in position 31 as they checked to ensure the hold was empty.
- The loader operator and leading hand did not adequately check the containers during the loading process, leading to the container in position 31 not being noticed.
- The individual conducting the loader operator role changed during the loading of the aircraft, which likely led to a misunderstanding of how much of the loading had been completed.
- The ground crew had additional tasks to complete during the unloading and a smaller ground team than normal, which led to the hold not being checked adequately.

- Physically touch each bulkhead wall after unloading is completed, to ensure no containers are left inside the aircraft.
- If there is no leading hand present, then no movement by the loader machine including unloading/loading will be undertaken.
- If there is no yellow ULA, then no loading is to be completed.
- Yellow ULA must be completed as each container is loaded
- Yellow ULA must be handed to the leading hand for cross checking before the white ULA is taken to the crew.
- Standardised communication between loader operators and leading hand to confirm that all containers have been unloaded.
- The leading hand is to conduct a mandatory visual check to ensure unloading has been completed before any loading commences for the new outbound flight.
