**Collision between Aircraft
and Tow Tractor
(Ground Handling)**

**Serious Incident Investigation
Final Report**

**Airbus A330-343, B-HLT,
Hong Kong International Airport
24 January 2020**

01-2021

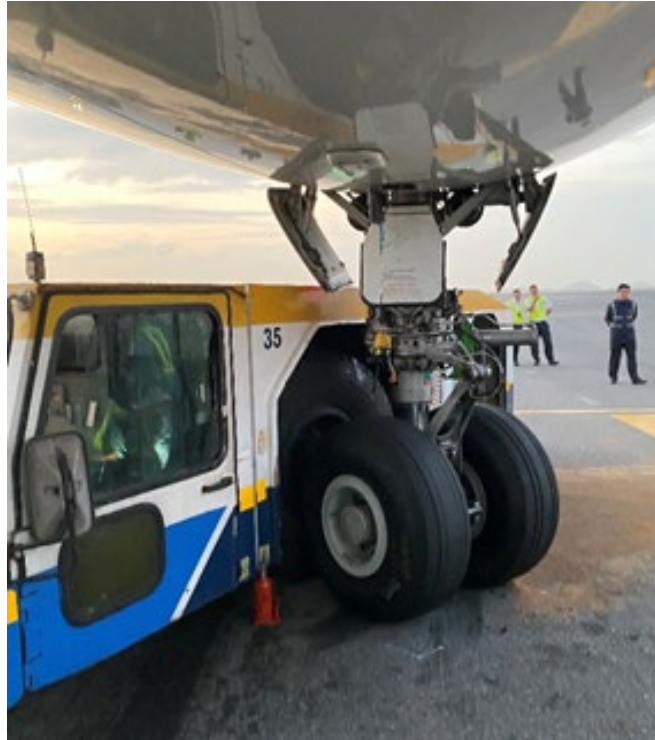
received the message for setting the parking brake to stop the aircraft movement. The NLG was damaged during the collision. (See Photo 1.)

Photo 1: NLG impacted with the Left Hand Side of the Tractor

The nose steering actuators of the NLG and the NLG door were damaged. There is no other structural damage evident. The investigation team did not establish any evidence of aircraft system fault that might be relevant to the serious incident.

- (6) Without parking brake set and chock in place, the aircraft, with both engines in idle power, rolled forward and collided with the tractor. [1.1(6)]

It is recommended that the Airport Authority Hong Kong considers amending Aircraft Departure Procedures of the Airport Operations Manual - Airfield Operations to require all ground handling companies to place chock in front of the NLG wheels before disconnecting the towbar from an aircraft after pushback operation.

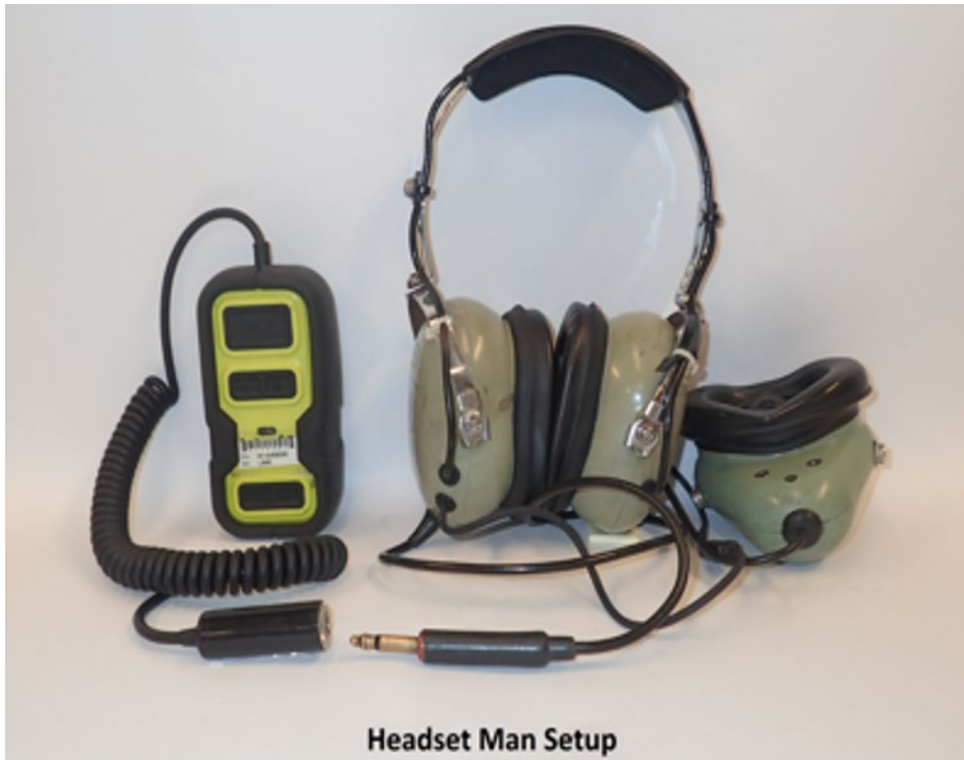
Photo 2: Wireless Headset Setup for Headset Man

The wireless headset setup, including the Bluetooth transceivers were checked and found normal after the serious incident. The cause of the communication interruption between ground and cockpit could not be identified. However, the possibility of system interruptions during the pushback operation could not be ruled out.

It is recommended that the Hong Kong Aircraft Engineering Company Limited establishes procedures in SOP for guiding ground handling personnel in case of loss of interphone communication with the flight crew during pushback operation.

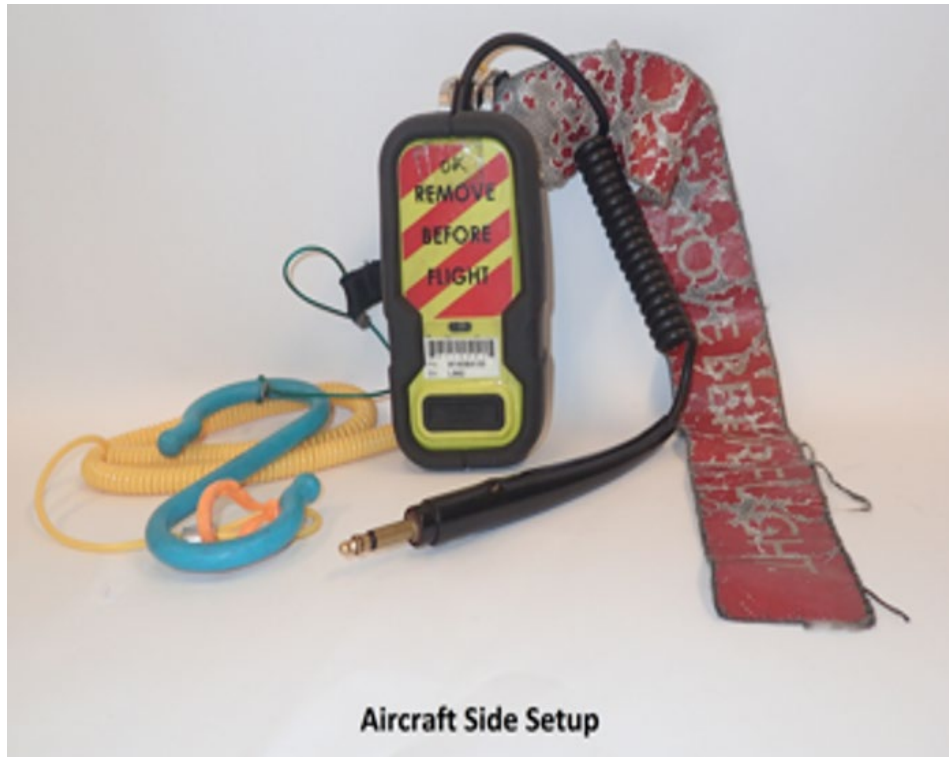
Photo 3: Wireless Headset Setup for Aircraft Side

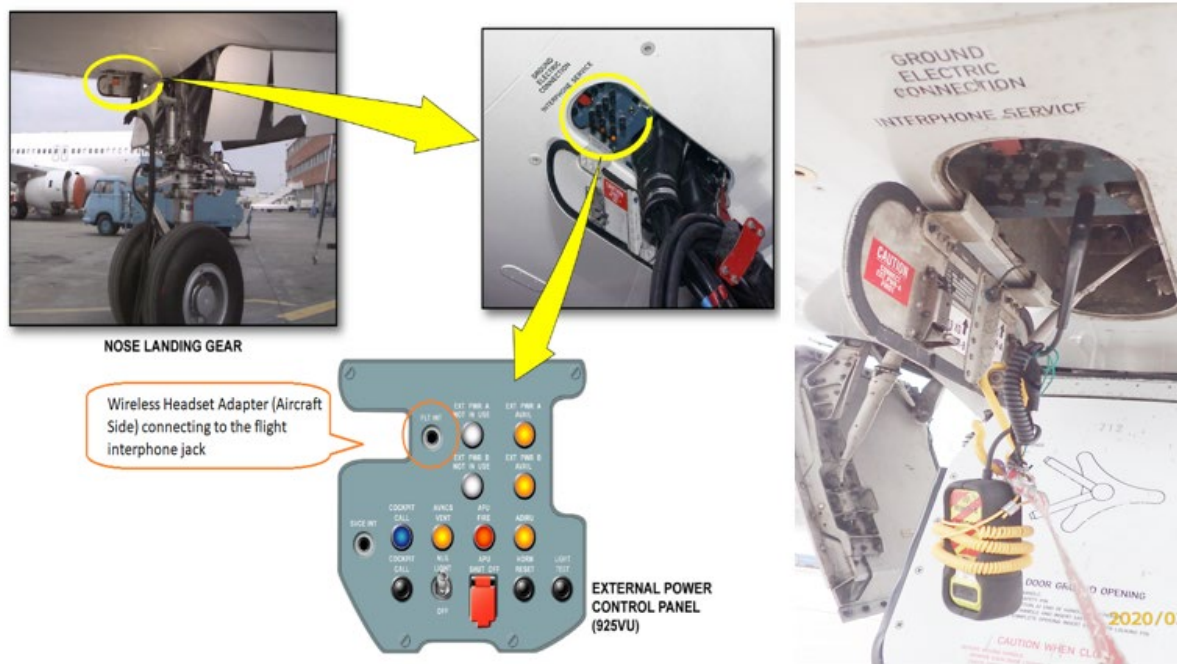
Figure 2: Wireless Headset Adapter Connection (Aircraft Side)
