Incident to the BOEING 737-900ER registered 4X-EHE

on 27 October 2019

at Paris-Charles de Gaulle (Val-d'Oise)

Cargo fire warning before taxiing, use of fire extinguishers, and disembarkation of passengers

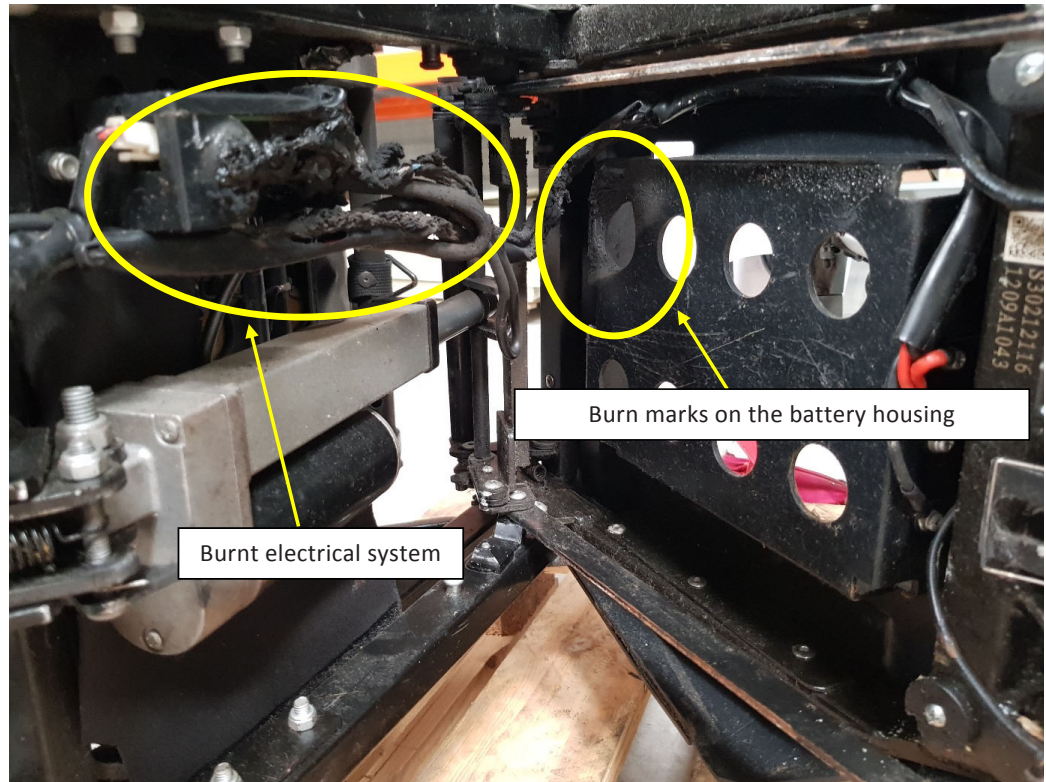
The wheelchair was severely damaged, probably due to the electrical system overheating. The battery showed no obvious signs of damage except for a few external burn marks which corresponded to the openings in the battery housing. A red canvas pouch was attached to the chair’s handles and exhibited burn marks. When the chair is in a vertical position, this pouch touches the battery.

Figure 2: Position of battery housing in relation to burnt electrical system, wheelchair partially unfolded

After the wheelchair had been secured in the aft hold of the aeroplane, a short circuit occurred in the wheelchair's electrical system for unknown reasons. The battery, still connected, sustained this short circuit which resulted in incipient combustion. The battery was in immediate contact with the combustion zone which could have created thermal runaway inside the battery.

- An unidentified internal fault which caused a short-circuit in the wheelchair’s electrical system.

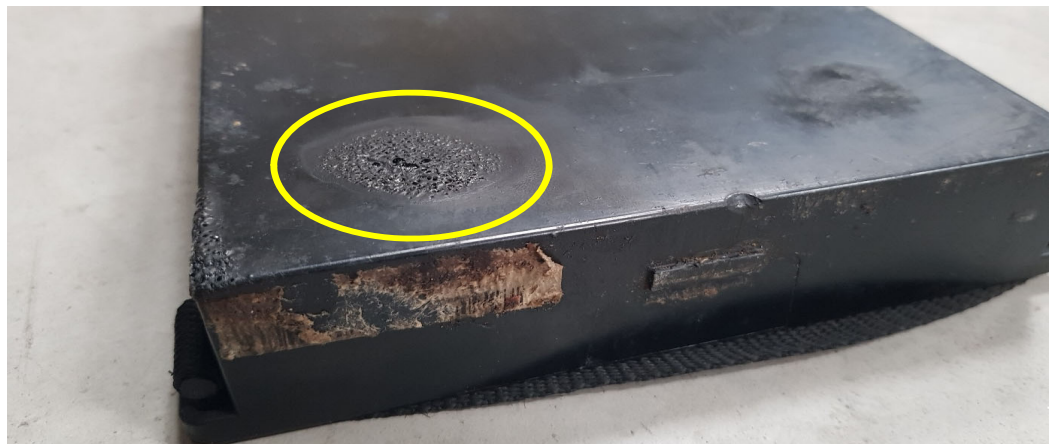
Figure 3: Burn marks on battery body, in relation to visible burn marks on housing
