# NATIONAL TRANSPORTATION SAFETY BOARD

## AIRCRAFT ACCIDENT REPORT

RYAN AIR SERVICE, INC.,  
FLIGHT 103, BEECH AIRCRAFT CORPORATION  
1900C, N401RA,  
HOMER, ALASKA,  
NOVEMBER 23, 1987

NTSB/AAR-88/11

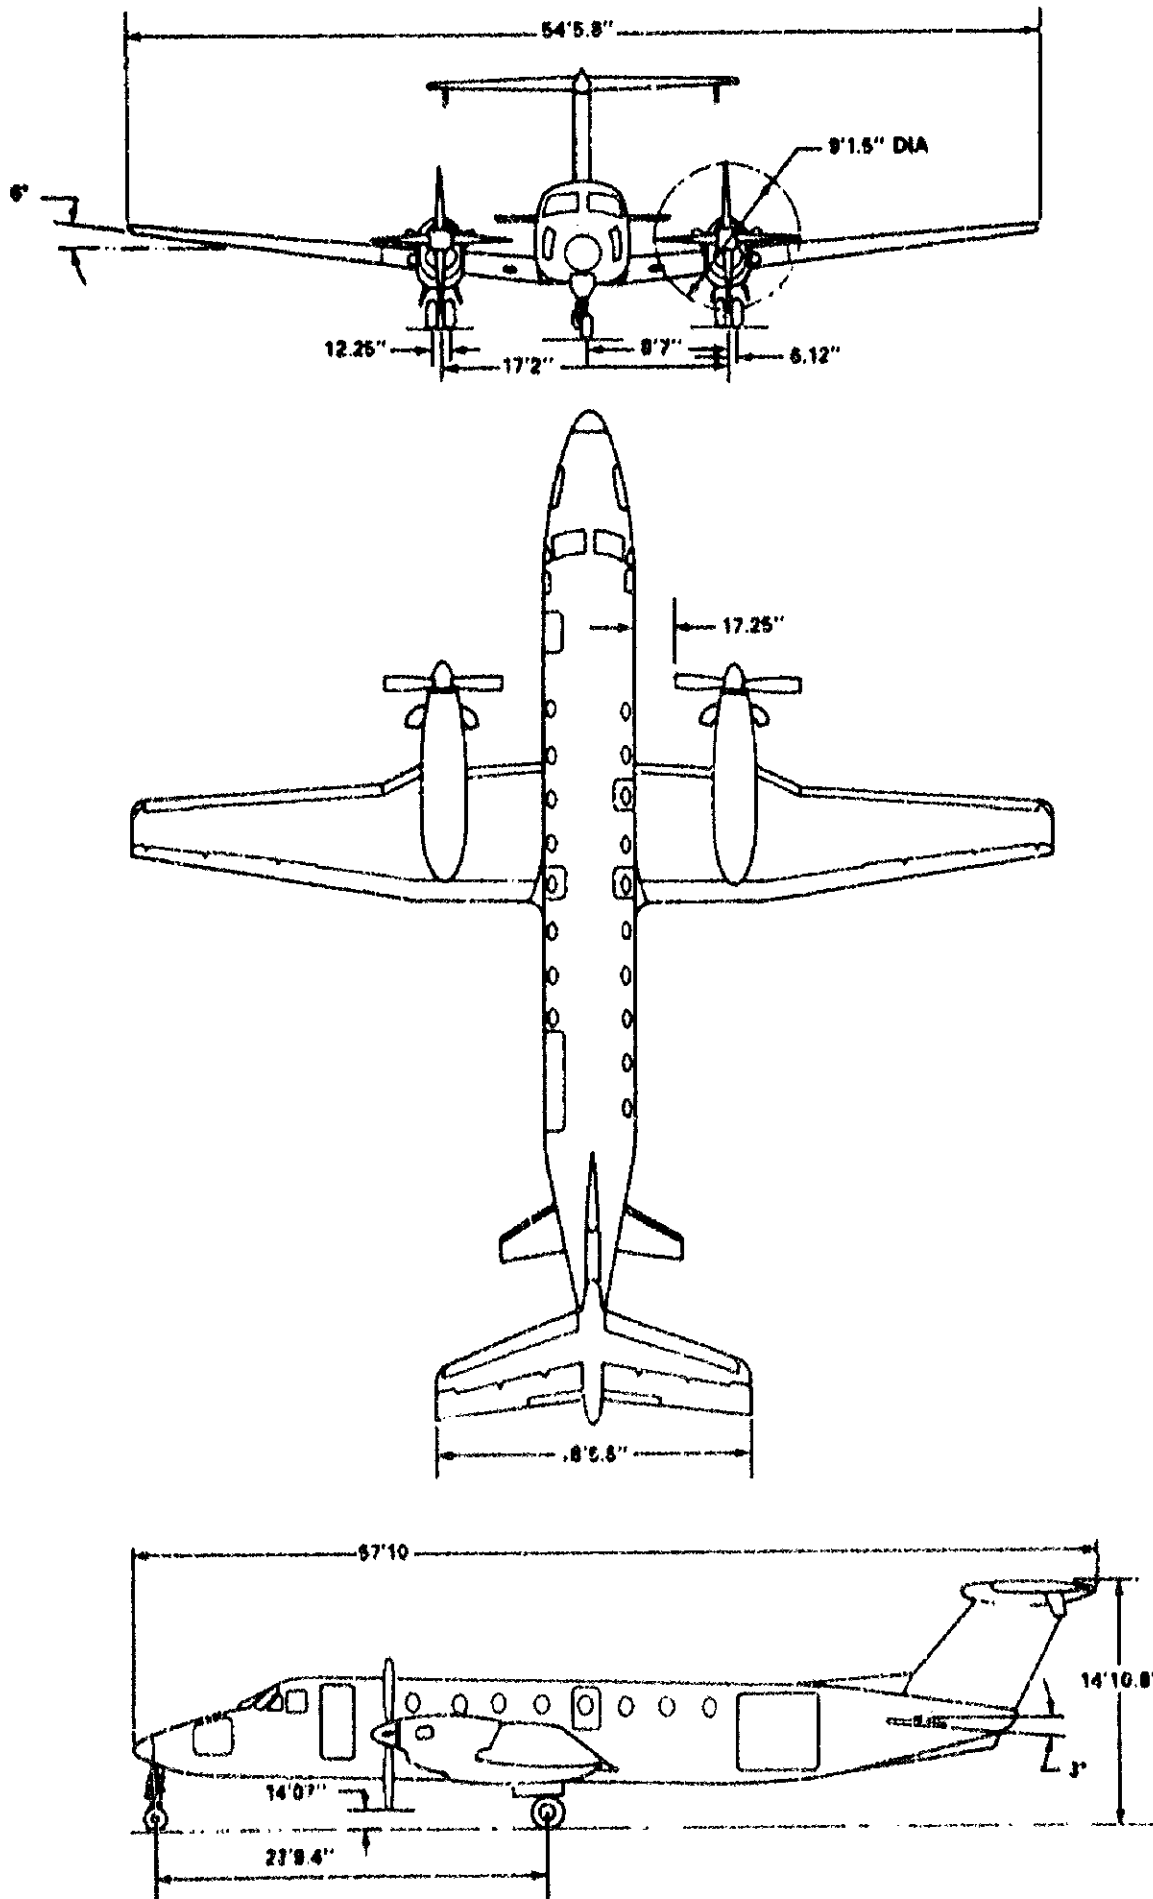
Figure 1.--Beech 1900C.

The Beech Aircraft Corporation, 1900C was certificated under the airworthiness rules of Title 14 Code of Federal Regulation (CFR) Part 23 and was operated under 14 CFR Part 135 in passenger service. The pressurized cabin had seating for 19 passengers and 2 flightcrew members. (See figure 1.) The airplane was equipped with two Pratt and Whitney PT6A-65B turbine engines, flat-rated at 1,100 shaft horsepower, each with Hartzell four-blade, full-feathering propellers.
