Air Accident Investigation Sector

- Investigation Summary Report -

AAIS Case N° AIFN/0001/2015

Ground Equipment Collision with Aircraft

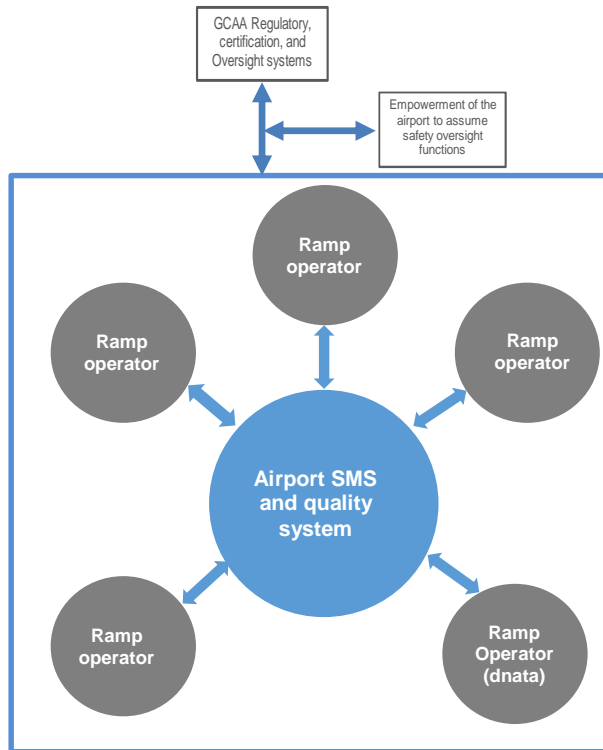
Figure 3. Network of SMS among airport and other operators

implementation of the SMS among all operators. Figure 3 illustrates a proposed SMS structure for the airport and the other operators.
