NATIONAL TRANSPORTATION SAFETY BOARD

AIRCRAFT ACCIDENT REPORT

UNCONTROLLED IMPACT WITH TERRAIN
FINE AIRLINES FLIGHT 101
DOUGLAS DC-8-61, N27UA
MIAMI, FLORIDA
AUGUST 7, 1997

Abstract: This report explains the accident involving Fine Airlines flight 101, a Douglas DC-8-61, which crashed after takeoff from runway 27R at Miami International Airport, Miami, Florida, on August 7, 1997. Safety issues in the report include the effects of improper cargo loading on airplane performance and handling, operator oversight of cargo loading and training of cargo loading personnel, the loss of critical flight data recorder information, and FAA surveillance of cargo carrier operations.

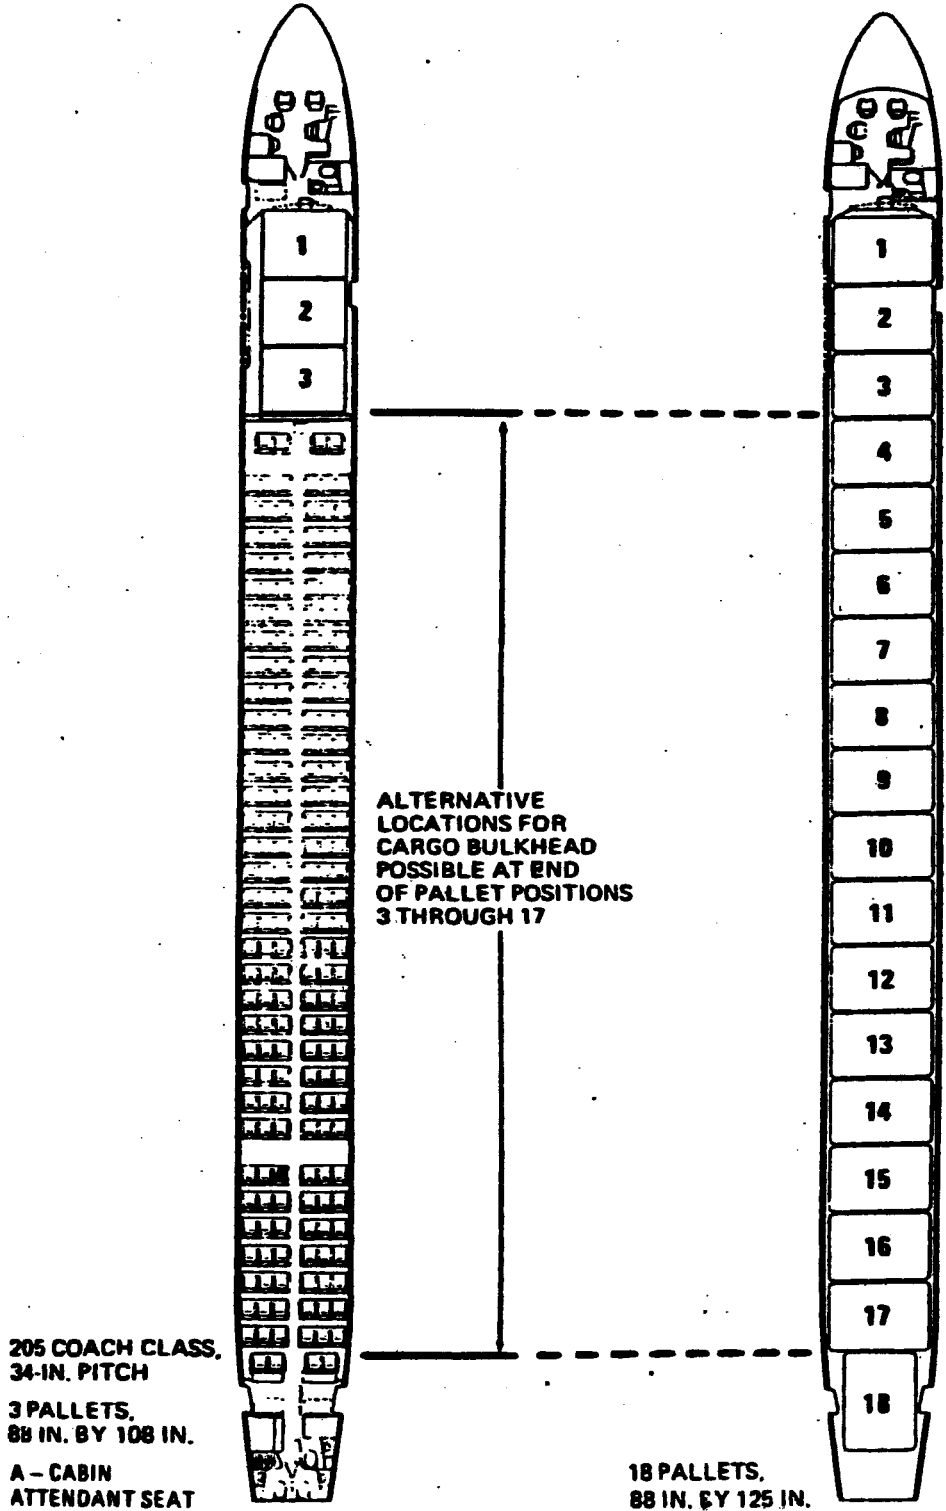
**MIXED PASSENGER AND CARGO MODE
205 PASSENGERS**

ALL FREIGHTER

Figure 1.—DC-8-61 18-pallet cargo configuration diagram.

The airplane was equipped with a cargo handling system designed to accommodate and restrain 18, 88-inch x 125-inch pallets. Five guide floor tracks with encased ball rollers were installed in the cabin floor to move cargo pallets forward or aft of the main cargo door. Retractable pallet locks (Pemco 50044-1 pallet lock assemblies), or "bear traps," were installed in the cabin floor along the five guide tracks (aligned in a row) at 89-inch intervals (see figure 2). Each of the 85 pallet locks included a folding lock mechanism (to allow pallets to move over them during loading) comprising a forward and aft facing pawl. When raised, the pawls engage the edges of adjoining cargo pallets and prevent forward, aft, or vertical pallet movement (see section 1.16.3 on load testing). Rails were attached along the cabin walls to prevent cargo from striking the fuselage. According to the loading system design, pallet positions 1 through 17 are loaded in the 125-inch (lateral) x 88-inch (longitudinal) position. Pallet position 18, located in the tapering end of the aft fuselage was reversed, loaded in the 125-inch (longitudinal) x 88-inch (lateral) position.

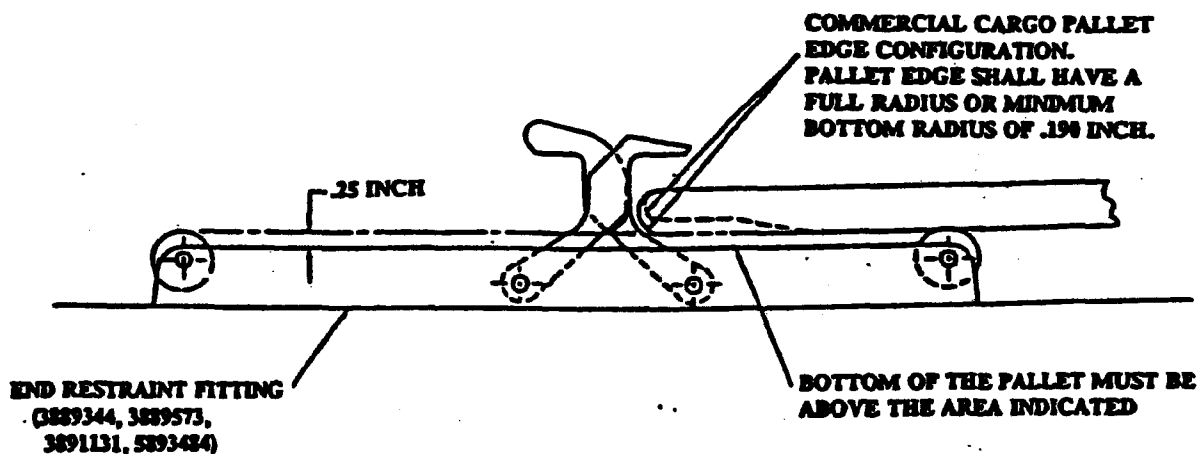
All commercial pallets used in cargo operations must conform to the restrictions shown in Figure 3, below. Specifically, the edges of pallets engaging the pawls of the end restraint fittings must have a full radius or a minimum bottom radius of .190 inch. In no case may the edge of a pallet be so configured that it extends into the shaded area shown in Figure 3.

Figure 2.—Pallet edge configuration requirements.
